ARL-STRUC-TM-503

Aircraft Structures Technical Memorandum 503

EVALUATION OF A DAMAGED F/A-18
HORIZONTAL STABILATOR (U)

J. PAUL

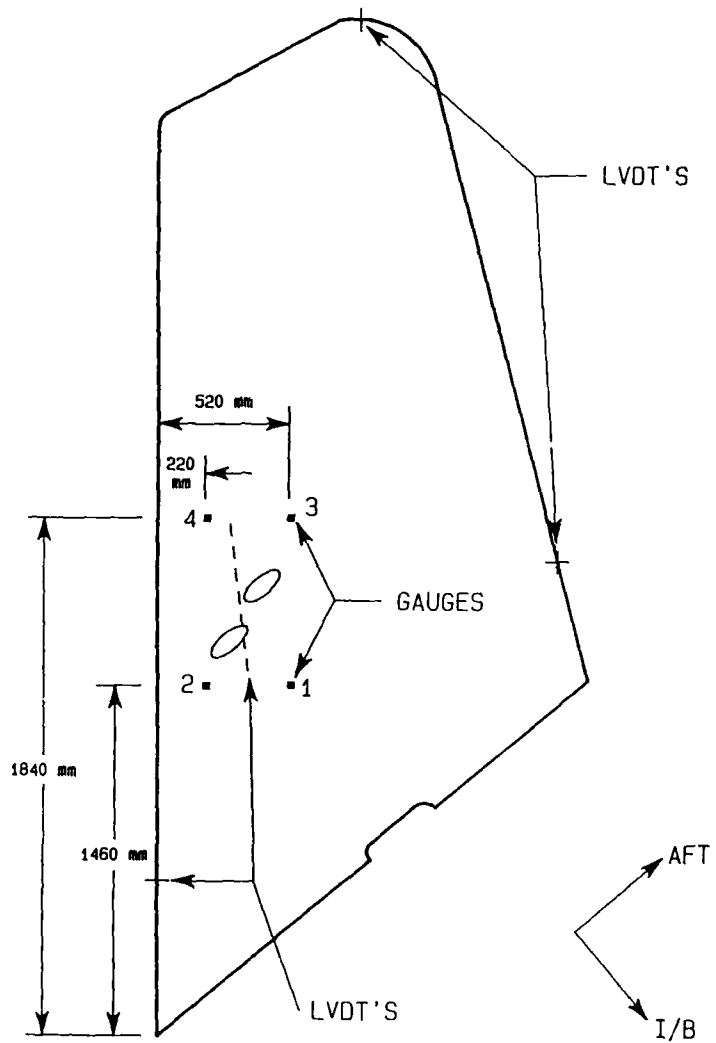
FIGURE 7 LOCATION OF STRAIN GAUGES AND DISPLACEMENT TRANSDUCERS

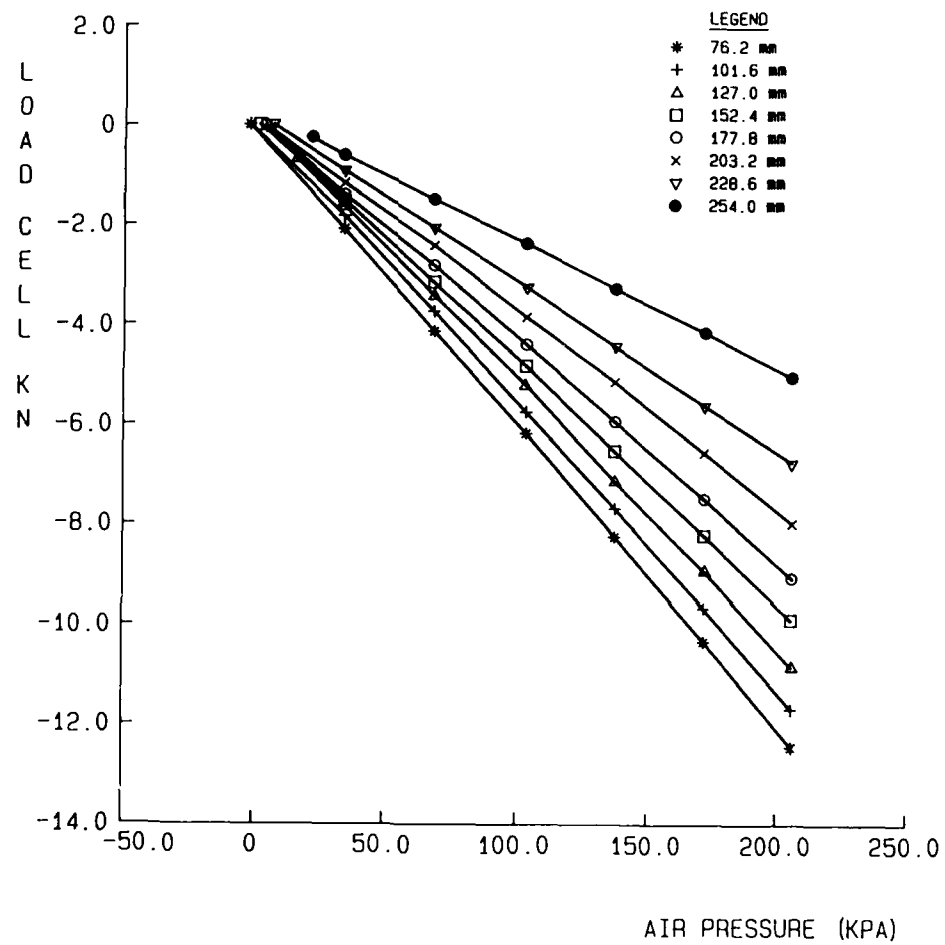
Displacement and pressure transducers were required to measure the extension and pressure for each air bag. The force applied by each air bag is a function of these two variables and was read off the calibration graph shown in Figure 9. The root bending moment (RBM) was calculated and used as the reference load applied to the structure. Three extra displacement transducers were attached to the stabilator at the tip, leading and trailing edges, see Figure 7, to measure tip displacement and torque induced by the applied load. A HP9816 data acquisition system was used to record the resulting 33

FIGURE 9 CALIBRATION CHART FOR THE FIRESTONE AIR BAG
